DESCRIPTION OF SURVEY FOR OTIS HOUSE

JOB#1656-4

| SURVEY FOR:<br><b>Otis House</b><br>1003 S Luck Ave, Zanesville, Ohio 43701 | |
| JOB NUMBER<br><b>JOB #1656</b> | DRAWING / SHEET NUMBER<br><b>PLAT #04</b> |

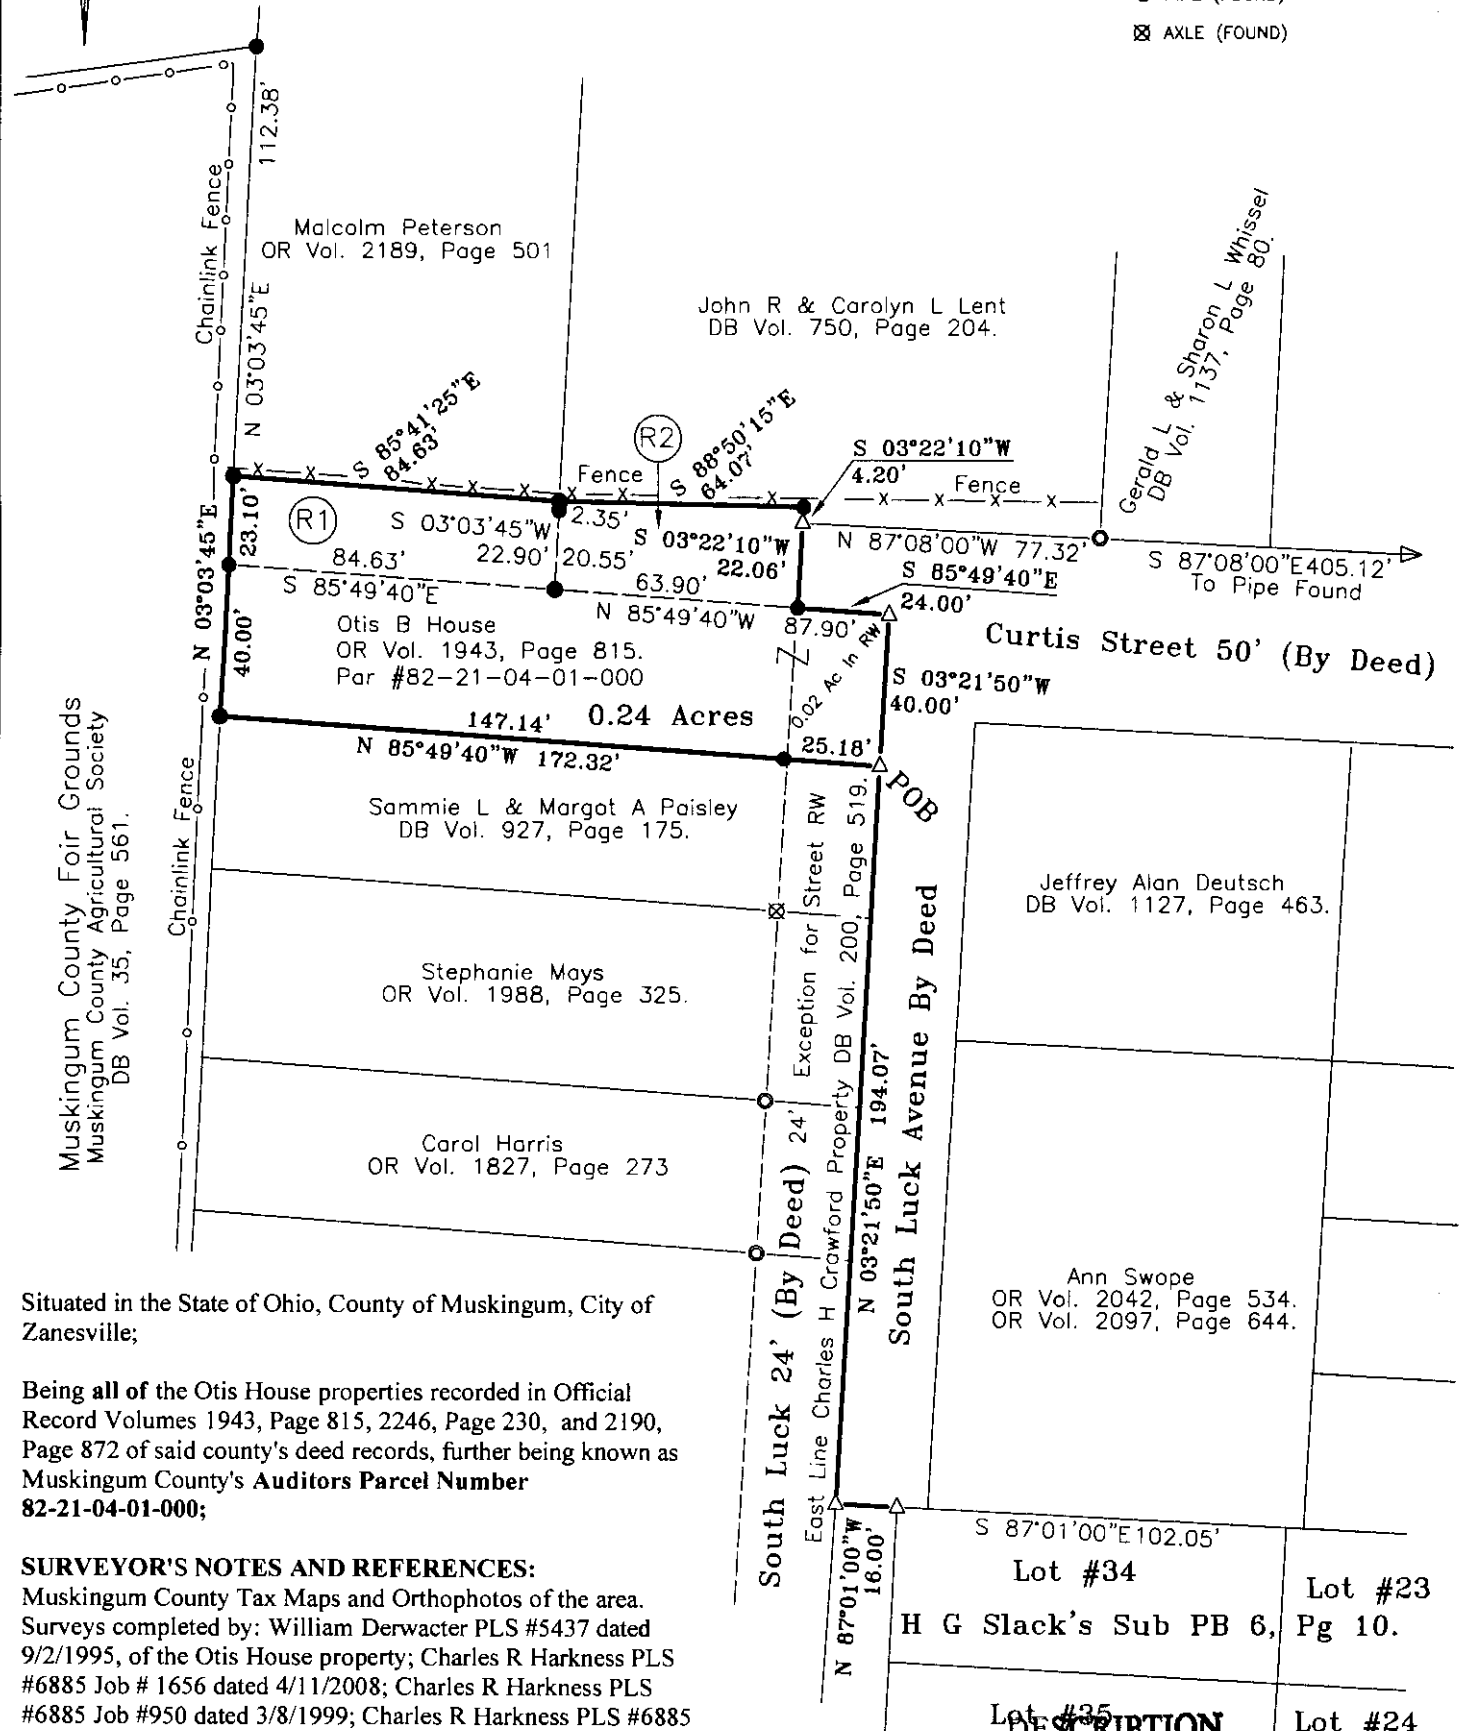
The bearings on this plat are based on State Plane Coordinate Grid (Ohio South 1983) derived from GPS Observations.

Being **all of** the Otis House properties recorded in Official Record Volumes 1943, Page 815, 2246, Page 230, and 2190, Page 872 of said county's deed records, further being known as Muskingum County's Auditors Parcel Number **82-21-04-01-000**;
