BRIDGE DETAILS

MUSKINGUM RECREATIONAL TRAIL  
ZANESVILLE, OHIO  
ELLIS BRIDGE RESTORATION  
BRIDGE DETAILS

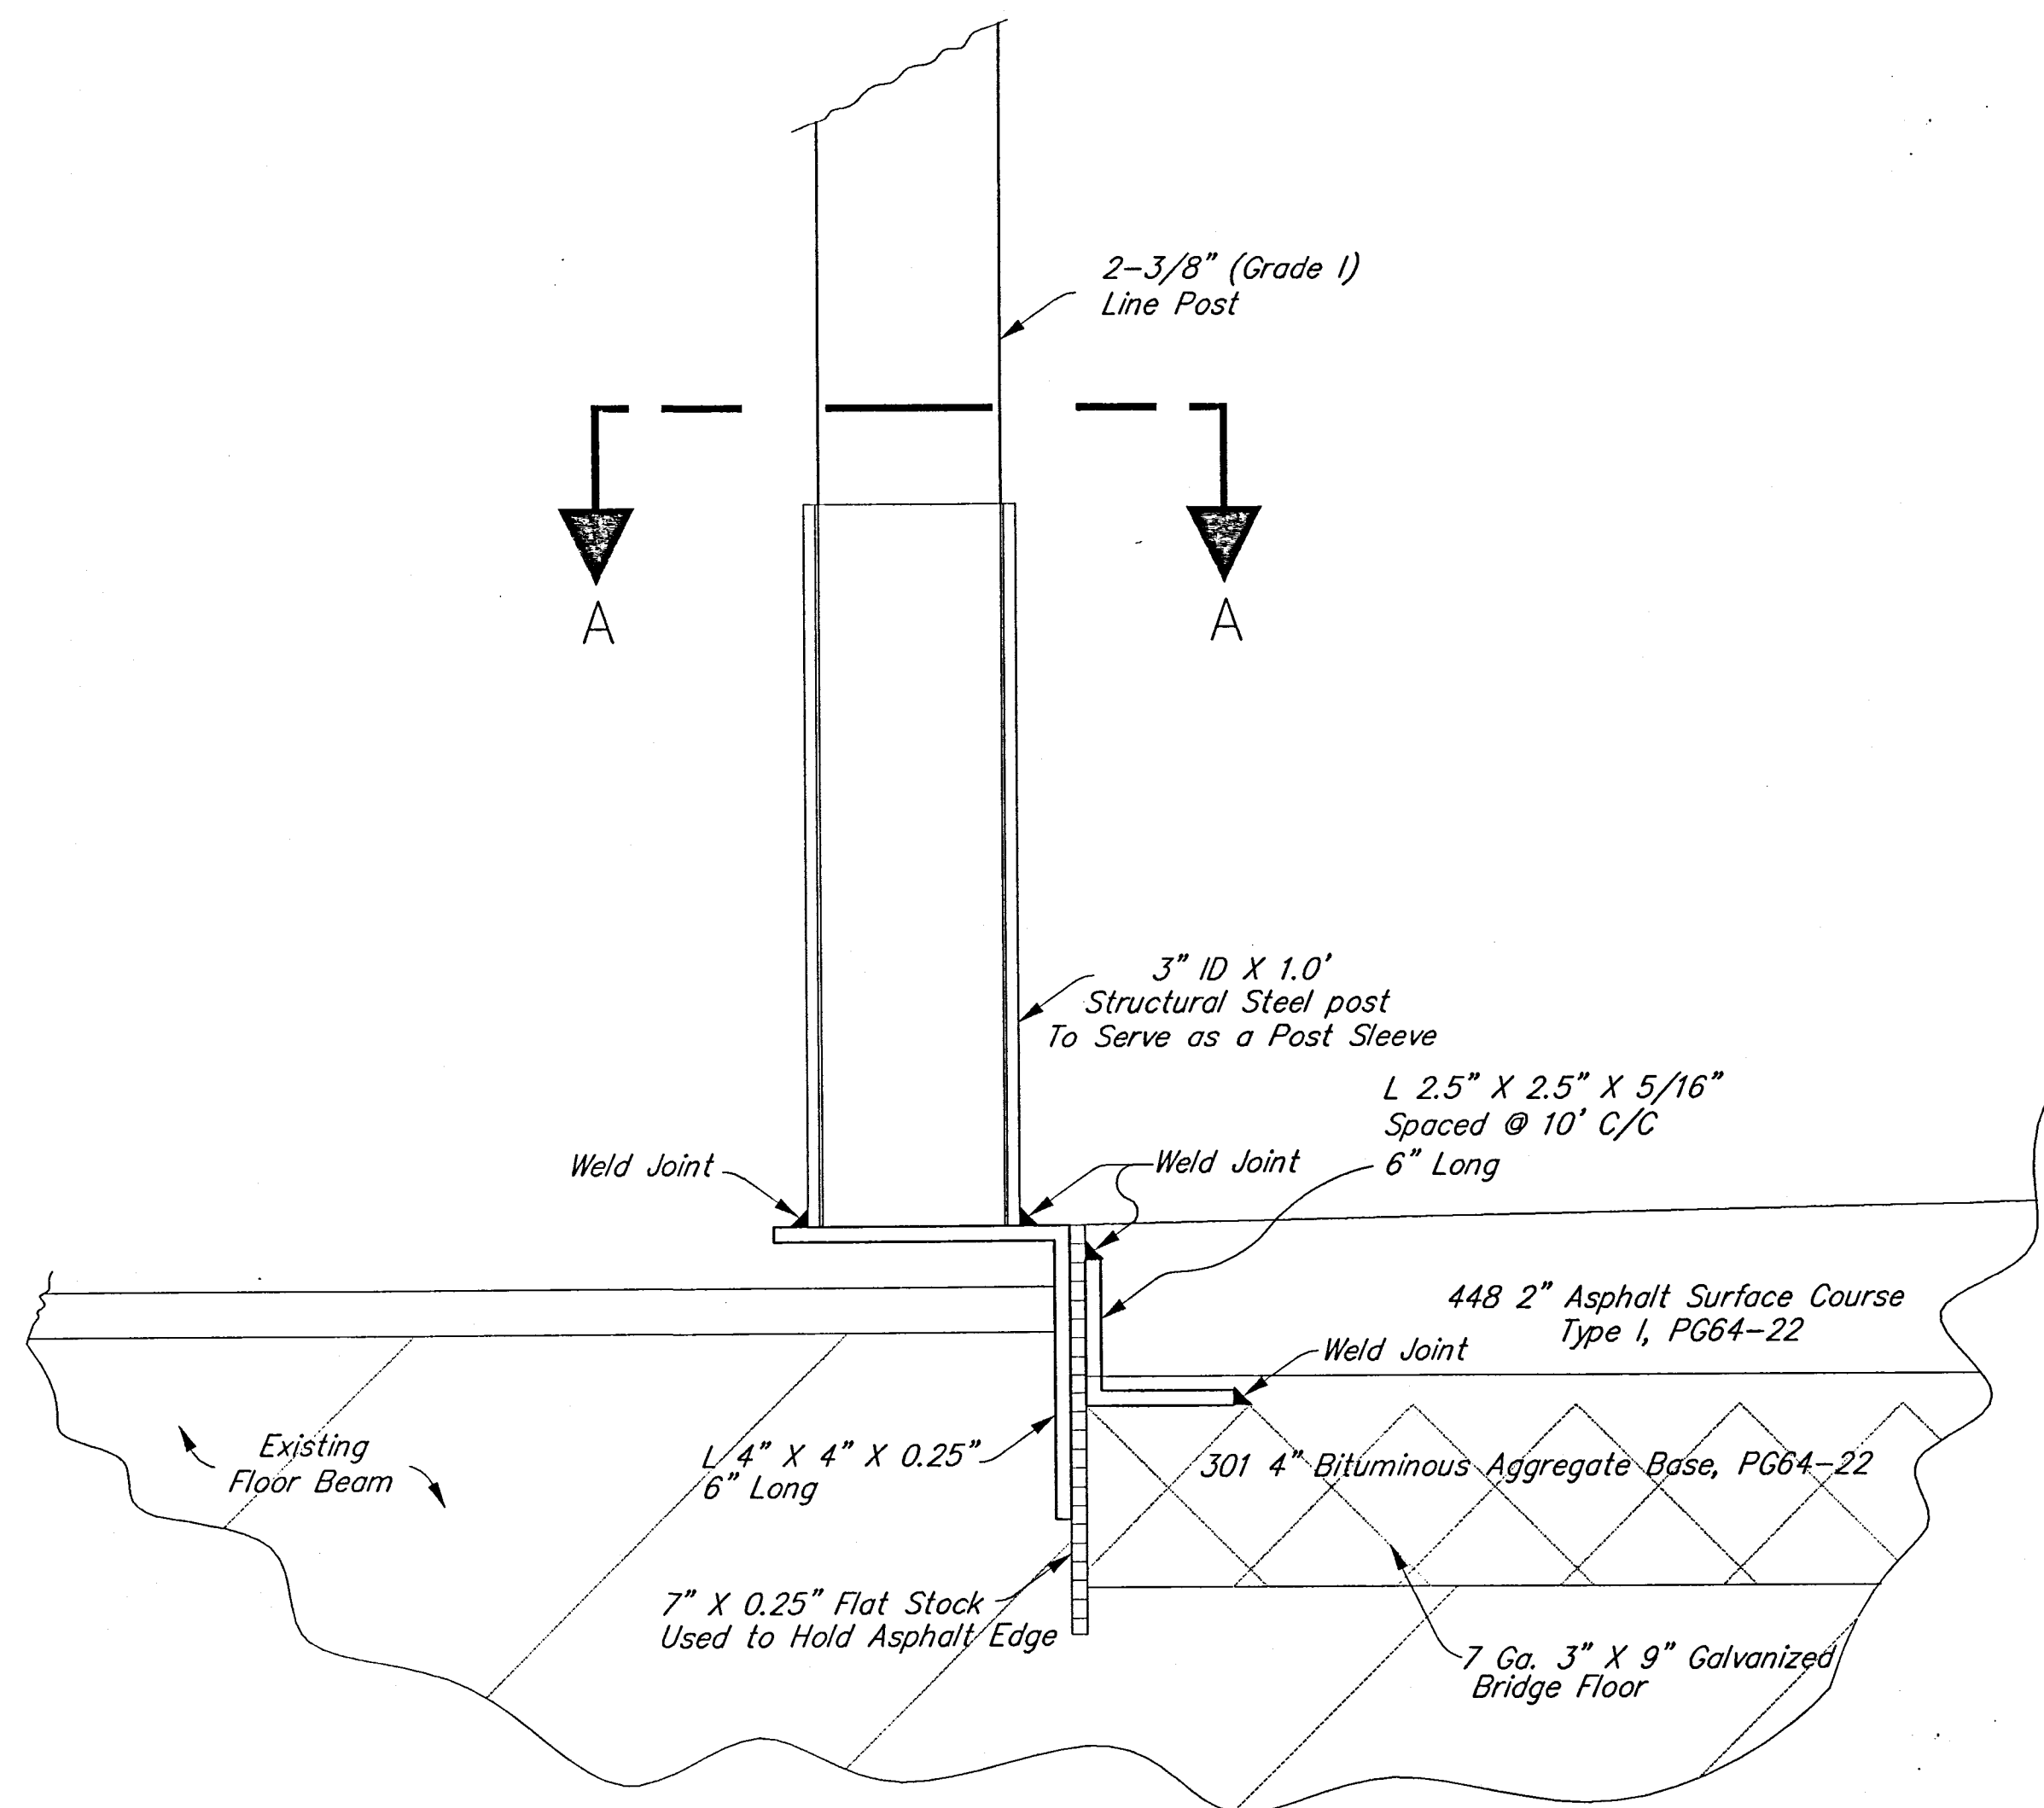
POST SUPPORT DETAIL

Note:  
Spacing of Post Supports @ 10' C/C,  
Field Adjust as Needed.
