Meigs Township  
S.E. Qtr. Section 20  
S.W. & S.E. Qtr. Section 21  
N.W. Qtr. Section 28  
T-12 N; R-11 W  
Muskingum County, Ohio

SURVEYED FOR: Mossy Oak Properties/ Five Starr Farms LLC

Caleb Jerome Galbraith  
Date: Feb 1, 2021  
Job ID: 1421

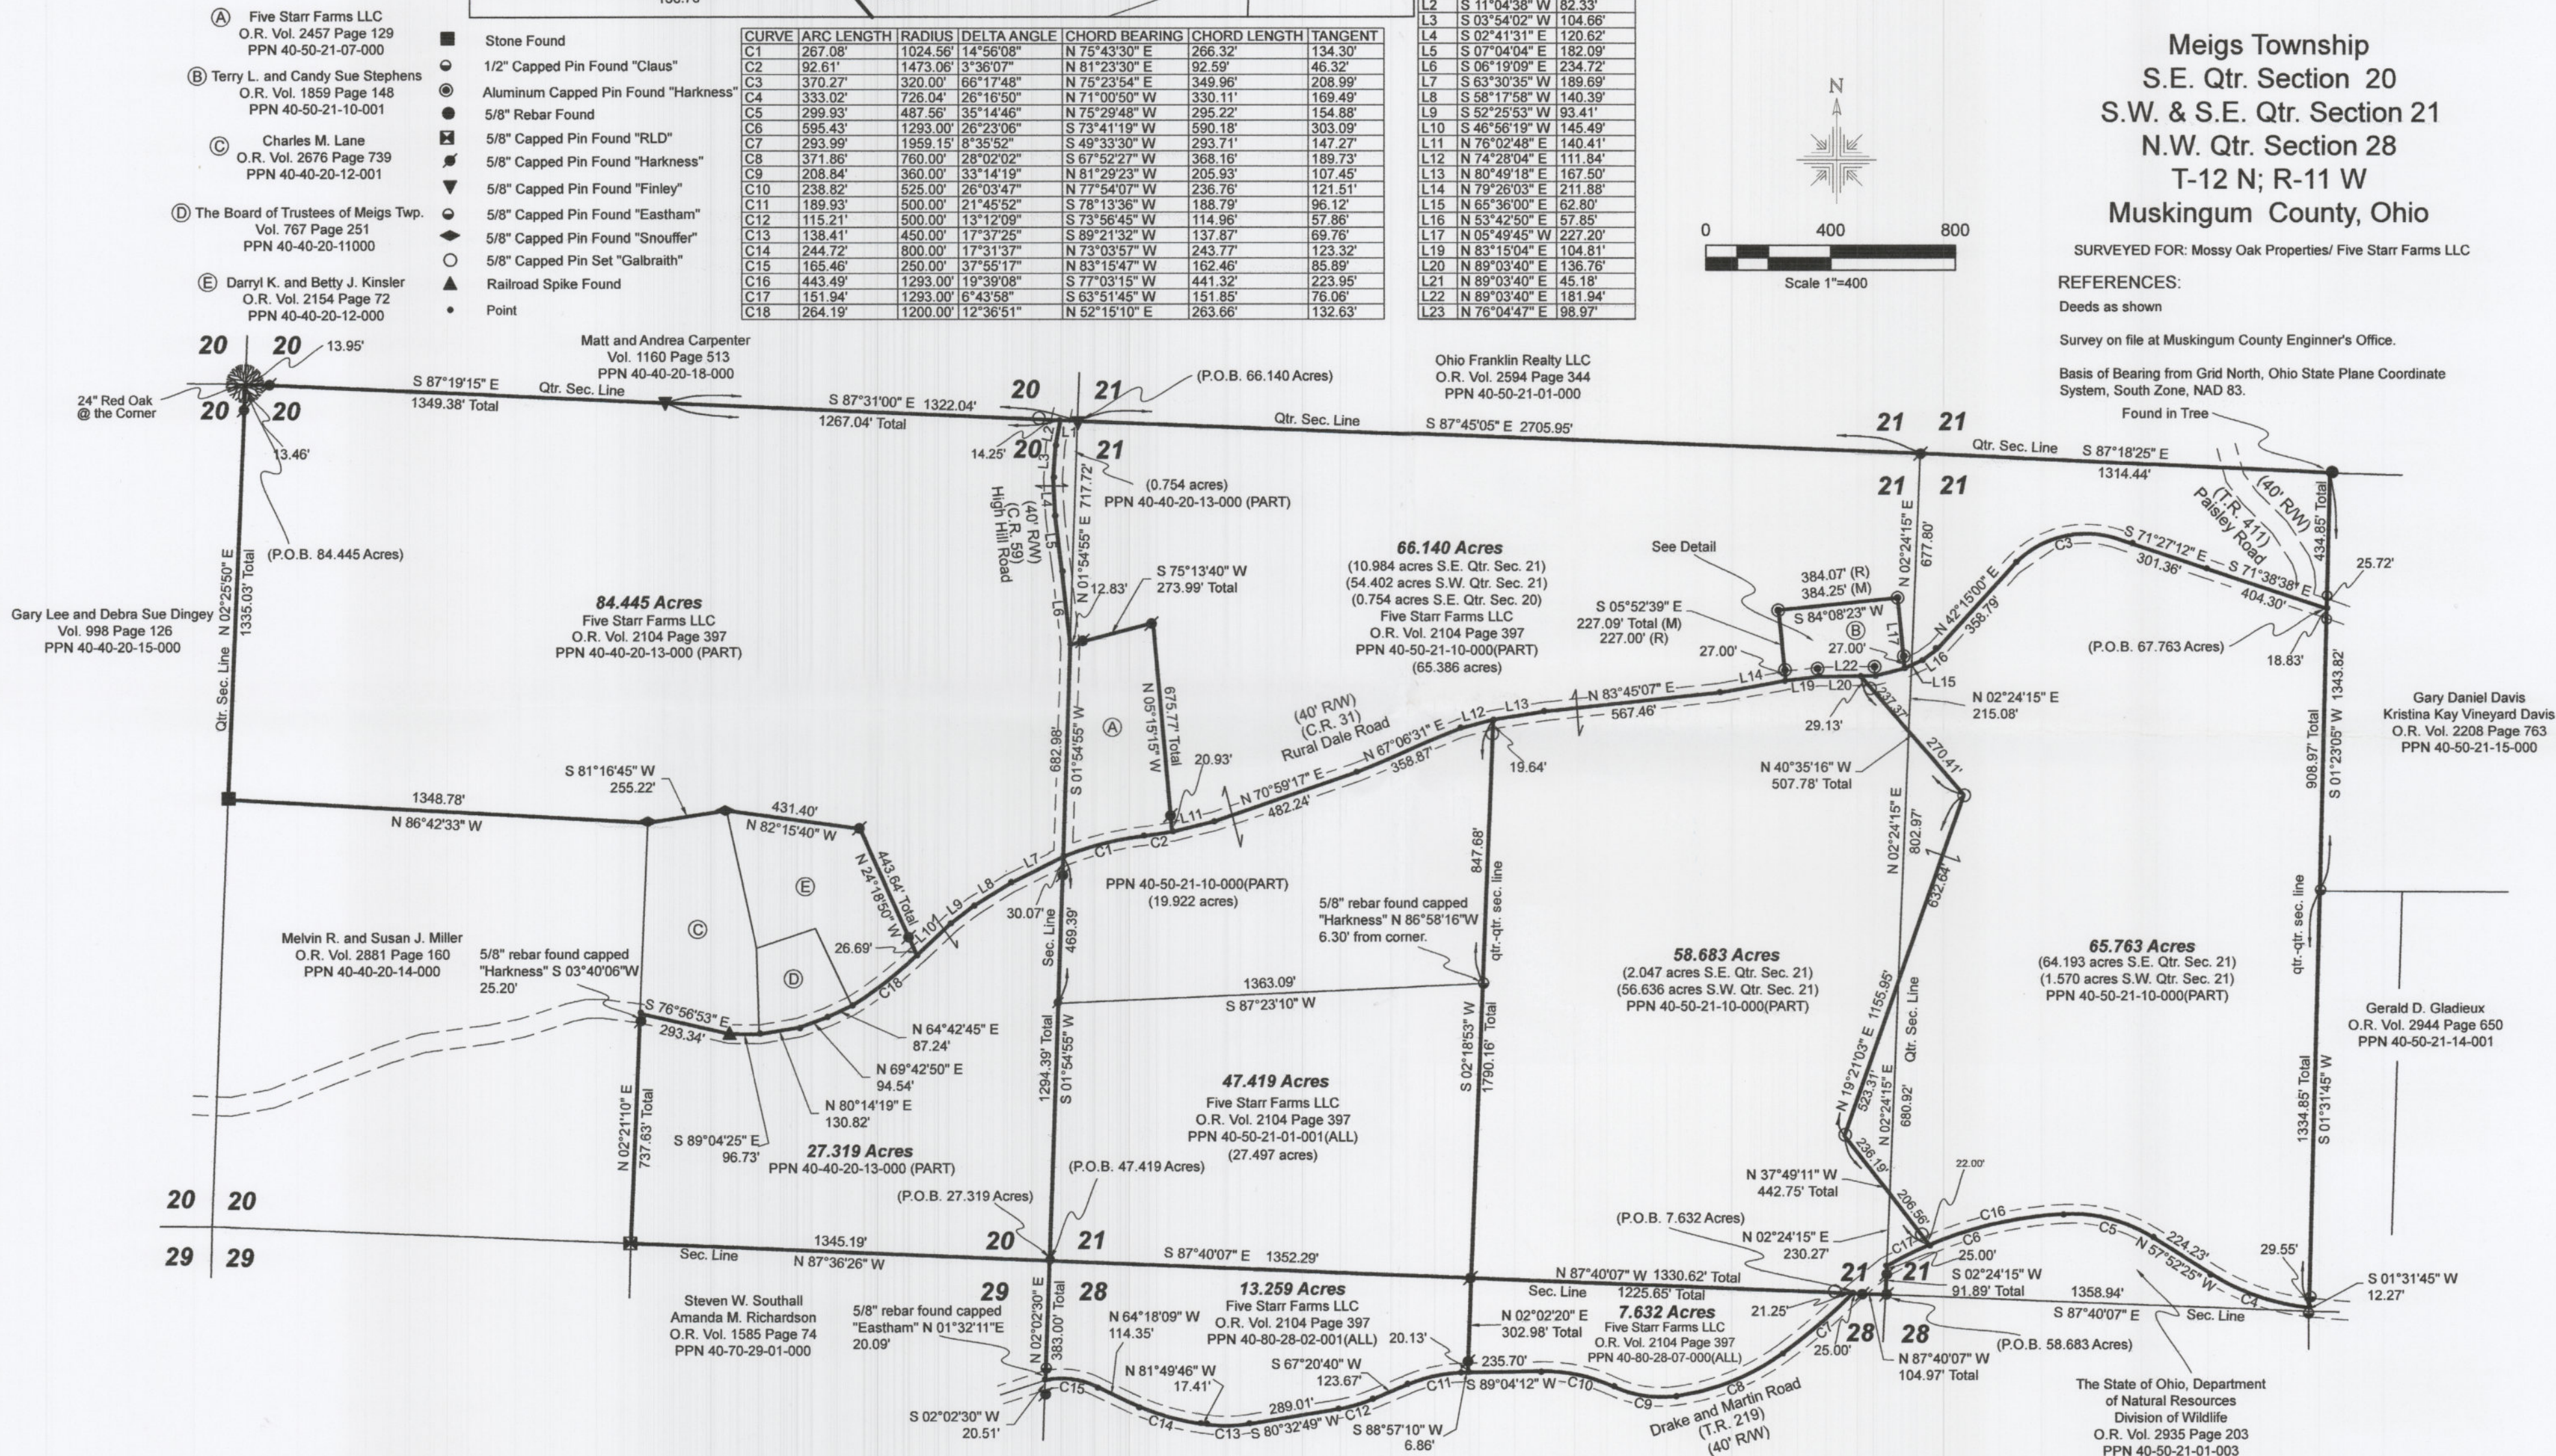
Basis of Bearing from Grid North, Ohio State Plane Coordinate System, South Zone, NAD 83.
